Lessons Learned from the GT-1 1U CubeSat Mission

Maximilian Kolhof, William Rawson, Radina Yanakieva, Andrew Loomis, E. Glenn Lightsey, Sterling Peet
Georgia Institute of Technology
620 Cherry St NW, Atlanta, GA, 30332; 703-579-7422
mkolhof3@gatech.edu

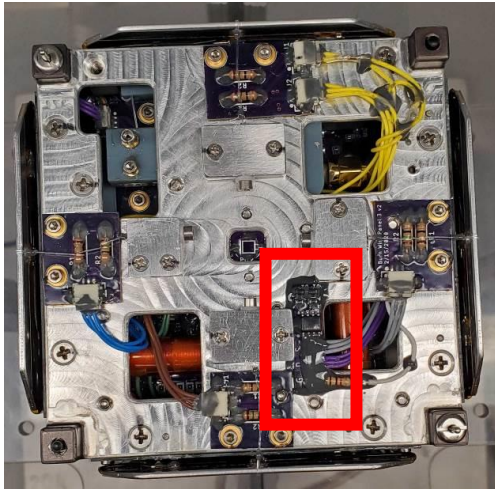
Prioritization of simple but flight-critical components can seem counter-intuitive but is nevertheless worth considering. The GT-1 spacecraft's battery hazard inhibit circuit is an example of an oversight in prioritizing a critical component. While the inhibit circuit (block diagram shown in Figure 5) is one of the most straightforward circuits to design on the spacecraft, it is arguably the most important. If this particular circuit does not meet payload requirements, the spacecraft cannot launch. The GT-1 team did not allocate additional time to develop a thorough understanding and ensure the inhibit circuit met requirements as it appeared simple to design relative to other circuits designed for the mission. Rather than supplying three independent battery hazard inhibits, the circuit was originally designed with only a single independent inhibit controlled by three trigger switches. The three trigger switches were mistakenly identified as three "independent" inhibits, but only controlled the

single inhibit mechanism. This circuit had to be redesigned and installed on the exterior of the spacecraft (Figure 9) after final integration which proved to be challenging and incurred additional risk to the mission.

Figure 9: Inhibit Circuit Modification PCB (outlined in red) mounted on spacecraft -Z plate

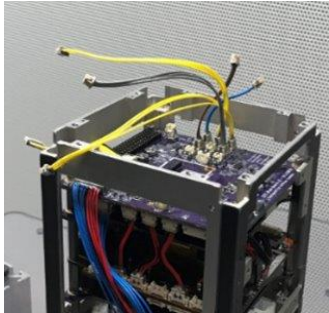
During tests of the deployable solar panels, anomalous behavior was observed on one of the burn wire mechanism PCBs. The root cause was speculated to be an overcurrent condition produced by a flipped cable which, with a reversed pinout, shorted power to ground. However, it was difficult to confirm this without taking apart the spacecraft. Photographs from the integration process taken just after several cable assemblies had

been installed confirmed that an incorrectly manufactured harness had indeed been installed into the spacecraft (Figure 12).

Figure 12: Image taken during integration helped to resolve a cable problem later in testing

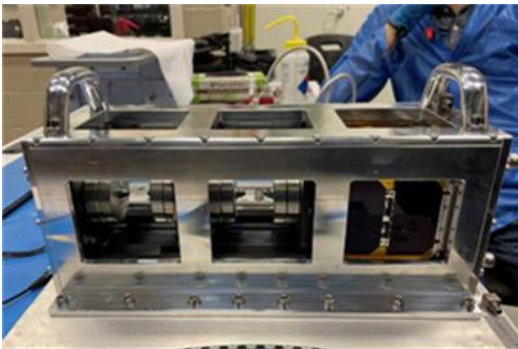
One of the most significant issues encountered during integration was poor fit of the spacecraft inside the test pod simulating the orbital deployer. This test pod was provided by JAXA to be used during testing to ensure that the assembled satellite will fit inside the launch case during integration and to be used for vibration testing. Upon initial assembly, GT-1 could be inserted into the test pod but could not slide freely, as required by the JEM Payload Accommodation Handbook ICD, and would bind at several points along the rails. The quality of the fit varied significantly depending on the order in which the various primary structural elements were torqued and based on the torque patterns used on a given face. These fit issues illustrate the importance of repeatable assembly procedures and designing parts for manufacturability.

Figure 14: J-SSOD Test Pod with GT-1 spacecraft and two 1U mass simulators

The troubleshooting process identified several likely causes for the improper fit in the test pod: machining errors which created nonconforming part dimensions, lack of proper tolerancing in the design, and poor structural design in which the CubeSat rails are divided among three different parts.

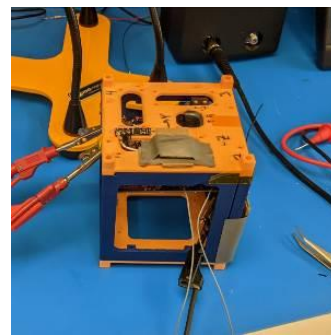
Figure 15: Inhibit Circuit Modification Test Setup

The importance of the next two steps, to develop a detailed procedure and practice this procedure on non-flight hardware, cannot be overemphasized. As discussed earlier, there should be some iteration between these steps to incrementally improve the procedure, and it is also possible that either writing or practicing the procedure will reveal that a particular solution is either impossible or riskier than initially believed which could prompt a return to step 4 and selection of a different alternative. In order to achieve consistent, reliable results, it is necessary to allocate significant effort into writing a detailed procedure to properly control the process, and into creating as accurate a test setup as possible to properly simulate the actual system. The less accurate a procedure or test setup is, the more uncertainty there is in whether the solution will actually be successful, and the greater likelihood that an unexpected error will be encountered when performing the final modification on the flight hardware. Figure 15 shows the test setup used to practice the GT-1 inhibit circuit modification using a 3D printed spacecraft structure (Figure 9 shows the installed inhibit circuit on the spacecraft).
